National Transportation Safety Board

Marine Accident Brief

Collision between Tanker *Chembulk Houston* and Container Ship *Monte Alegre*

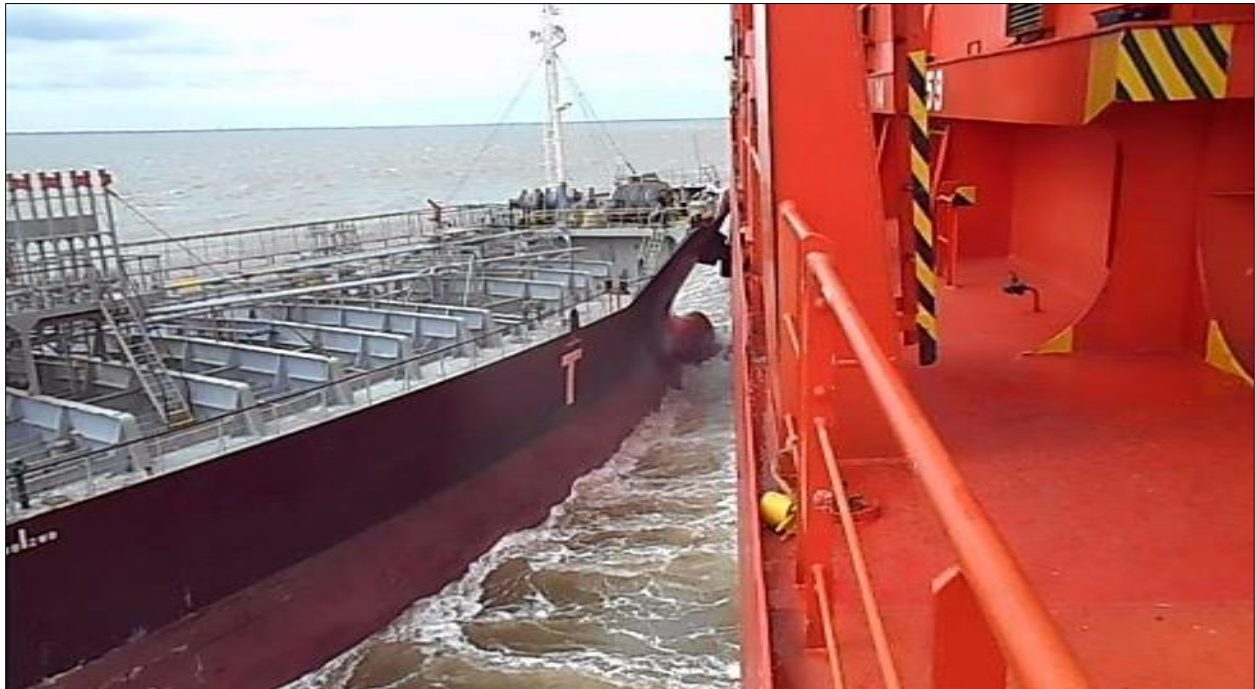
During the next 4 minutes, the deputy pilot on the *Chembulk Houston* issued several helm and throttle commands, ranging from hard port to hard starboard and from dead slow ahead to full ahead, that were intended to prevent the tanker from making contact with the *Monte Alegre*. Despite these efforts, at 1334, the starboard-side bow and anchor of the *Chembulk Houston* collided with the *Monte Alegre*’s aft portside hull, and the ships remained in contact as the tanker progressed forward. At the time of the collision, the speed of the *Chembulk Houston* was 9.2 knots and the speed of the *Monte Alegre* was 9.6 knots. Both vessels veered to port and grounded on the soft bottom of the Houston Ship Channel near light no. 39.

Still image extracted from video on board the *Monte Alegre*, showing the *Chembulk Houston*'s starboard-side bow and anchor in contact with the *Monte Alegre*'s port side. The initial contact occurred farther aft on the *Monte Alegre*.
